FIELD PERFORMANCE REPORT

Field Reference: Lyman Hall High School

Report Number: 90595/0700s

Issue Date: 9th December 2015

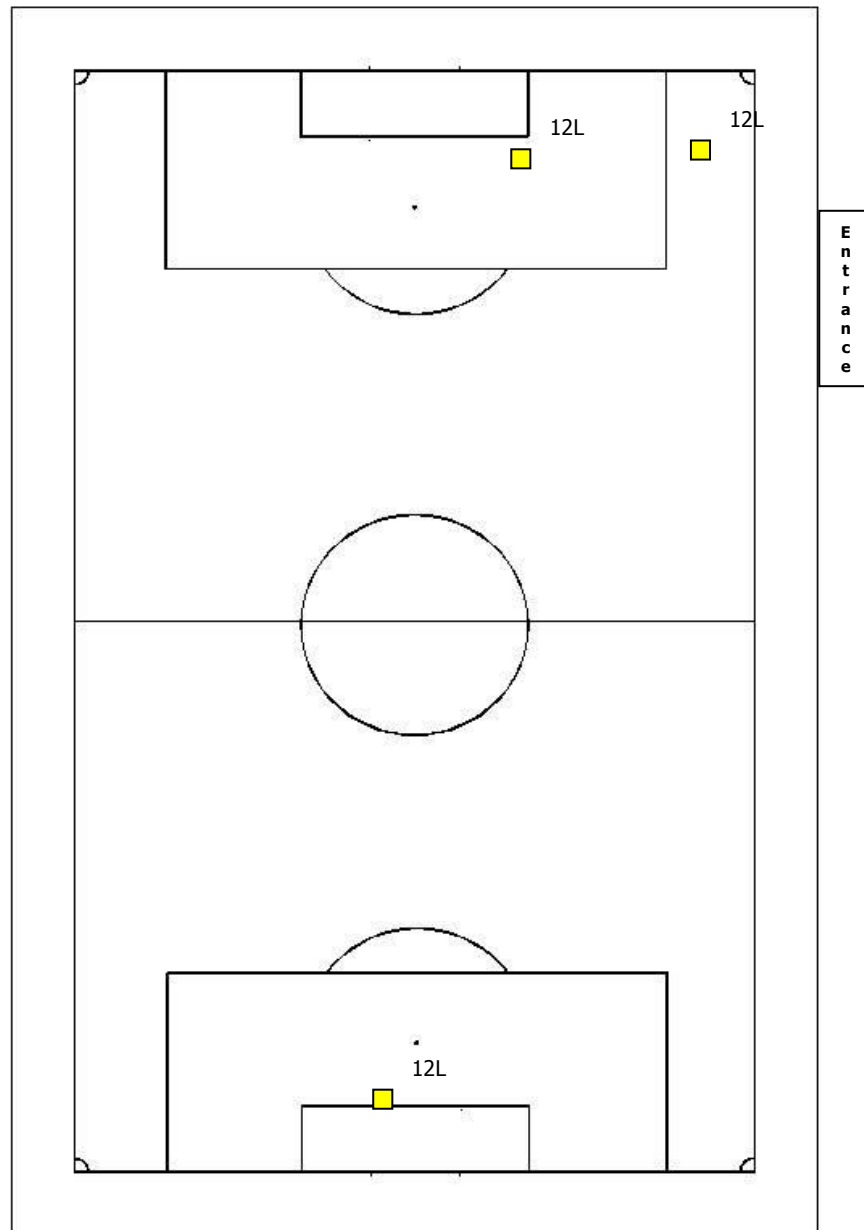
3.1 SURFACE REGULARITY AND DIMENSIONS

Property	Test Position					
	1	2	3	4	5	6
Vertical ball Rebound (m)	0.67	0.67	0.76	0.75	0.75	0.61
Ball Roll (m)	9.0	9.1	8.8	9.0	8.0	8.6
Rotational Resistance (Nm)	38	39	43	40	39	39
No. of deviations in surface.	3					
Values in RED denote failure of client's specified limits

Plan showing surface irregularities exceeding maximum requirement of 10mm under a 3m straight edge.

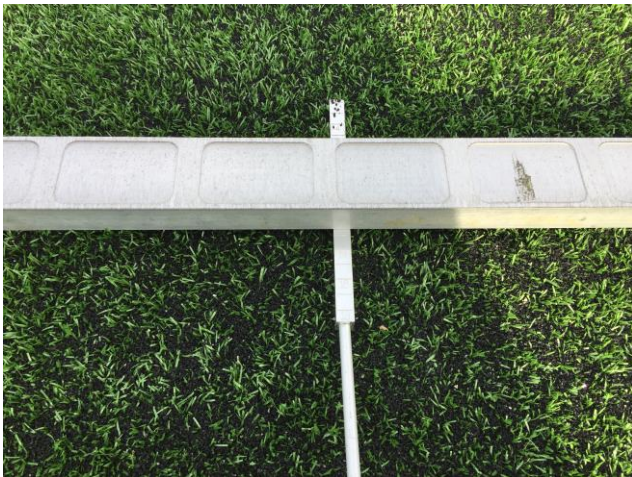
DEVIATIONS

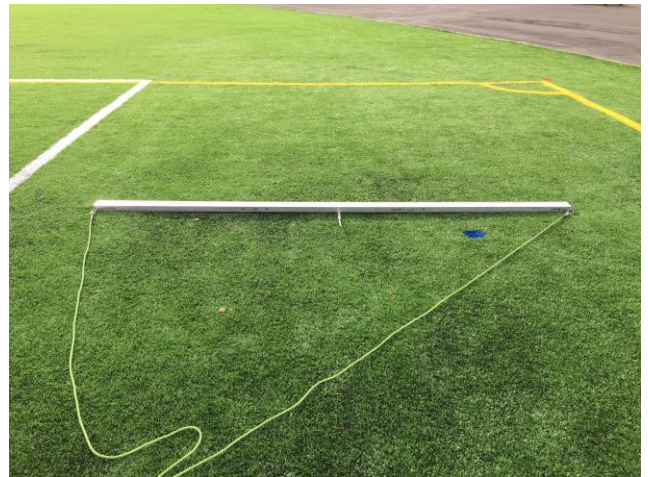
DEVIATIONS

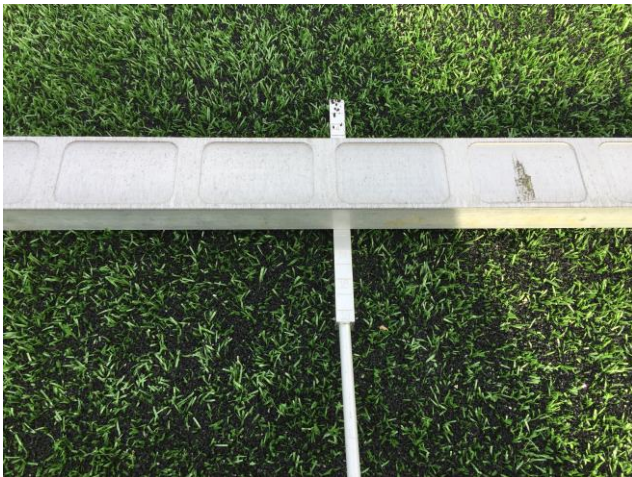
DEVIATIONS

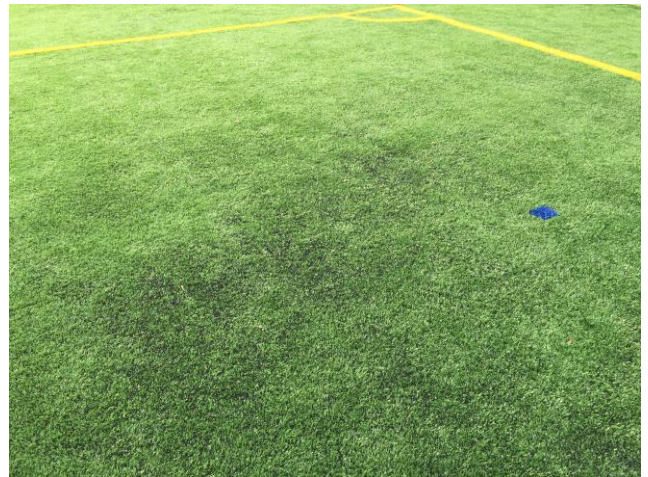
DEVIATIONS
